N32G430 Series Errata Sheet V1.3.0

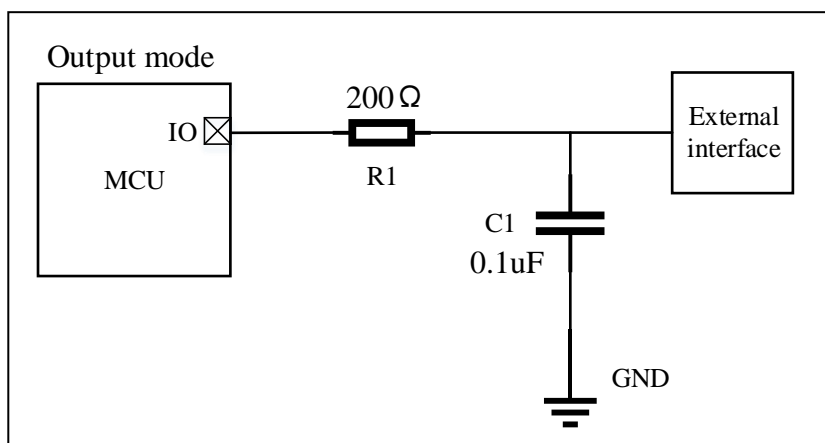
6.1 IO appeared burr during power-on

When the MCU is powered on, some IOs will have burrs appeared.

When IO is used as input, the burr has no effect on MCU; When IO is used as output, 200Ohm resistor and 0.1uF capacitor are applied for filtering.
