## N32G430 Series Errata Sheet V1.4.0

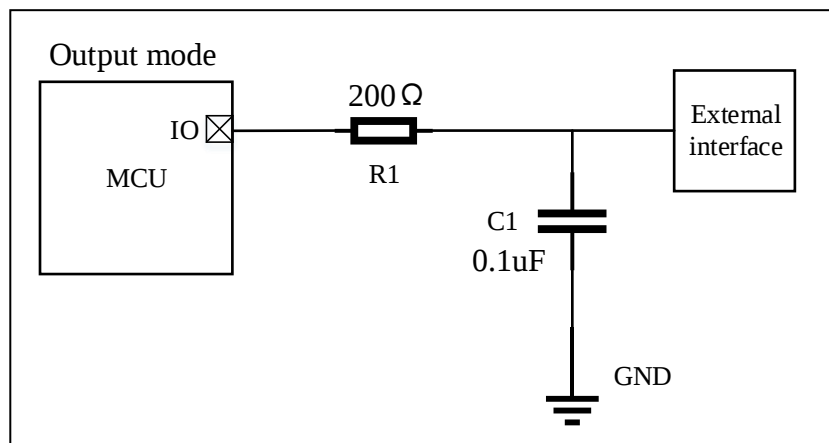
When the MCU is powered on, some IOs will have burrs appeared.

When IO is used as input, the burr has no effect on MCU; When IO is used as output, 200Ohm resistor and 0.1uF capacitor are applied for filtering.
