N32G401 Series Errata Sheet V1.1.0

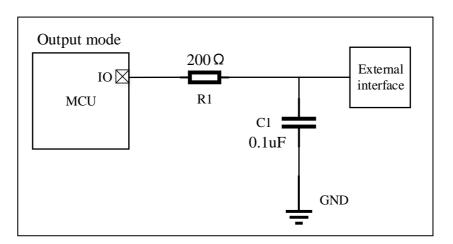
6.1 **IO appeared burr during power-on**

When the MCU is powered on, some IOs will have burrs appeared.

When IO is used as input, the burr has no effect on MCU; When IO is used as output, 2000hm resistor and 0.1uF capacitor are applied for filtering.
