N32G401 Series Errata Sheet V1.0.0

1 Errata List

Table 1-1 Errata overview

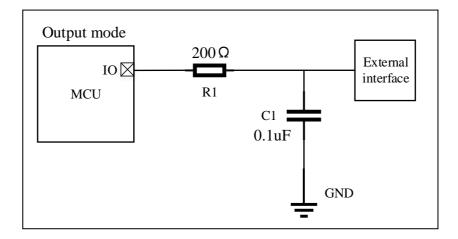
6.1 IO appeared burr during power-on

When the MCU is powered on, some IOs will have burrs appeared.

When IO is used as input, the burr has no effect on MCU; When IO is used as output, 2000hm resistor and 0.1uF capacitor are applied for filtering.
