User Guide for N32WB03x Firmware Update

This document presents the principle of N32WB03X firmware update and examples to help users familiarize with the firmware update process for rapid development.

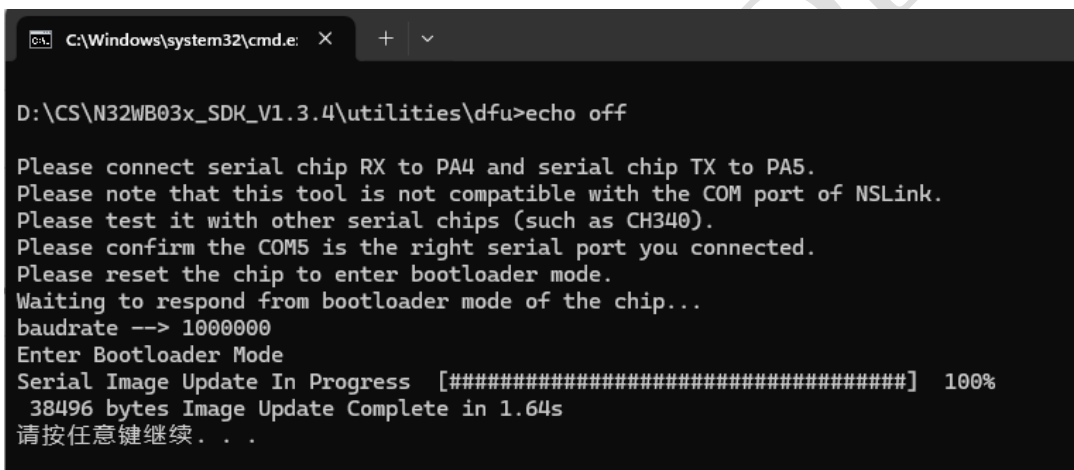
Double click the script file *UartFirmwareUpdate.bat* to view the print results in the Command Prompt.

Please connect serial chip RX to PA4 and serial chip TX to PA5.
Please note that this tool is not compatible with the COM port of NSLink.
Please test it with other serial chips (such as CH340).
Please confirm the COM5 is the right serial port you connected.
Please reset the chip to enter bootloader mode.
Waiting to respond from bootloader mode of the chip...
baudrate --> 1000000
Enter Bootloader Mode
Serial Image Update In Progress [#####] 100%
38496 bytes Image Update Complete in 1.64s
请按任意键继续...

It updates bank1(APPl) by default.

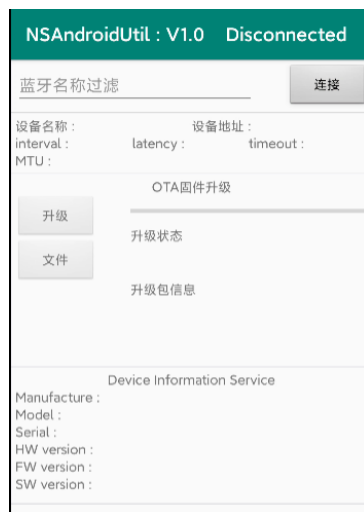
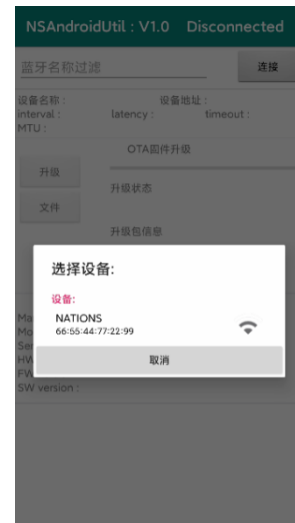
Click Connect, and then select the NATIONS (MAC: 66:55:44:77:22:99) device.

Wait until the Bluetooth in the upper right corner is Connected, then click the file and select *ota_dual_Bank.zip*.

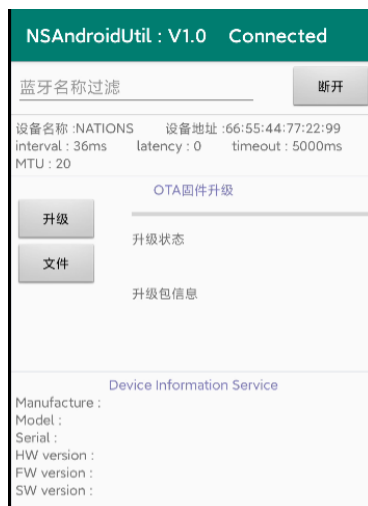
We can view the size of update package in the update package information. After we click Update, the update status changes and the progress bar increases.

As the update finishes, the Bluetooth will automatically disconnect, and the update status displays the update time consumed.

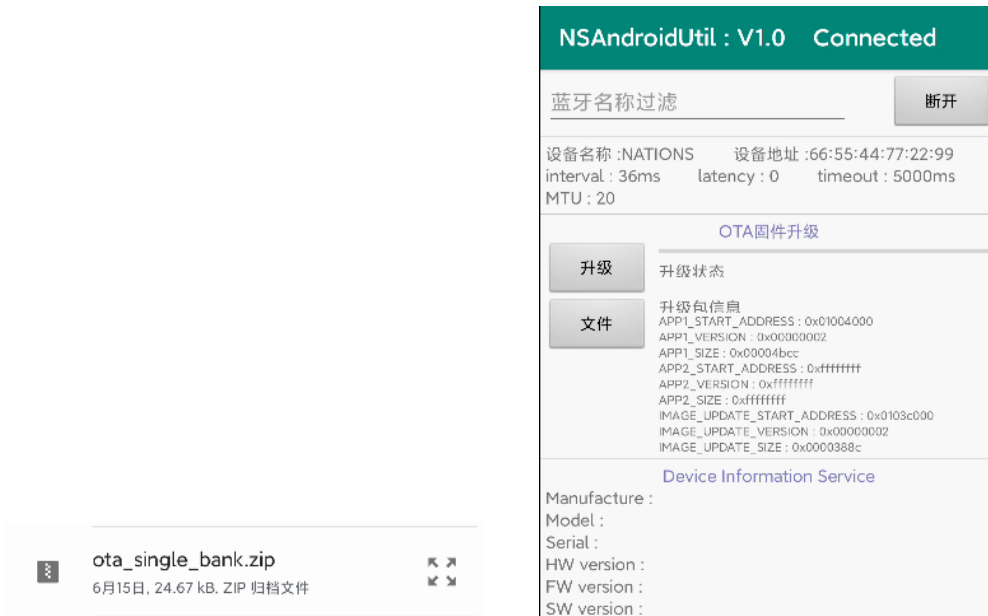
Wait until the Bluetooth in the upper right corner is Connected, click the file and select file *ota_single_Bank.zip*.

We can view the size of update package in the update package information. After we click Update, the update status changes and the progress bar increases.

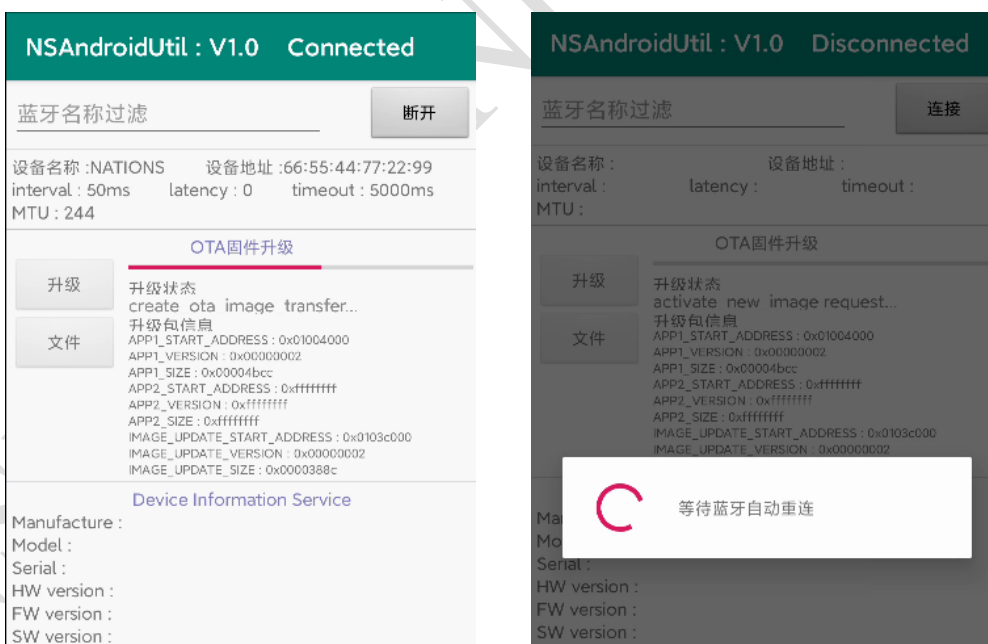
The single bank update Bluetooth will be disconnected and reconnected once. A dialog box will pop up on the interface to ask the user to wait for the automatic reconnection of Bluetooth.

The update continues after the Bluetooth is reconnected, and the update time consumed will be displayed as long as the update finishes.

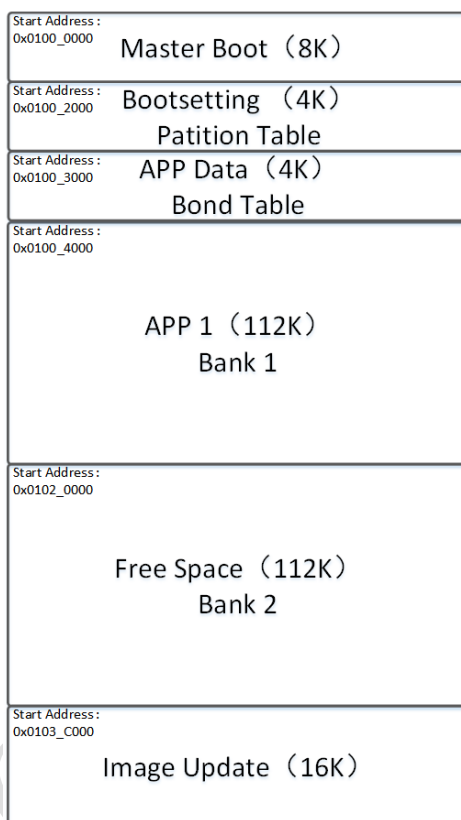
FLASH address range of N32WB03x chip is 0x0100_0000 - 0x0103_FFFF and the free space is 256K bytes.

The program and data FLASH is distributed as follows:

Name	N32WB03X FLASH address	Description
Master Boot (program)	0x0100_0000 – 0x0100_1FFF (8K)	Program entry after power on; Read the partition table and jump the program; Serial port update function;
Bootsetting (data) (Patition Table)	0x0100_2000 -0x0100_2FFF (4K)	FLASH partition table;
APP Data (data) (Bond Table) (User Data)	0x0100_3000 -0x0100_3FFF (4K)	APP data storage area; Storage binding list (about 500 bytes for 5 devices); The remaining space stores user-defined data;
APP 1 (program) (Bank 1)	0x0100_4000 -0x0101_FFFF (112K)	User program 1 storage area;
Free Space/APP2 (program) (Bank 2)	0x0102_0000 -0x0103_BFFF (112K)	Reserved space; or user program 2 storage area;

Image Update (program)	0x0103_C000 -0x0103_FFFF (16K)	Reserved space; or update “single BANK”;
-------------------------	---------------------------------	---

The MasterBoot program provides program jump entry and serial port update.

Bootsetting data provides program jump and updates shared data.

APP1 is a user program.

APP2 is a user program compiled on Bank2.

ImageUpdate is a program for “single bank” update.

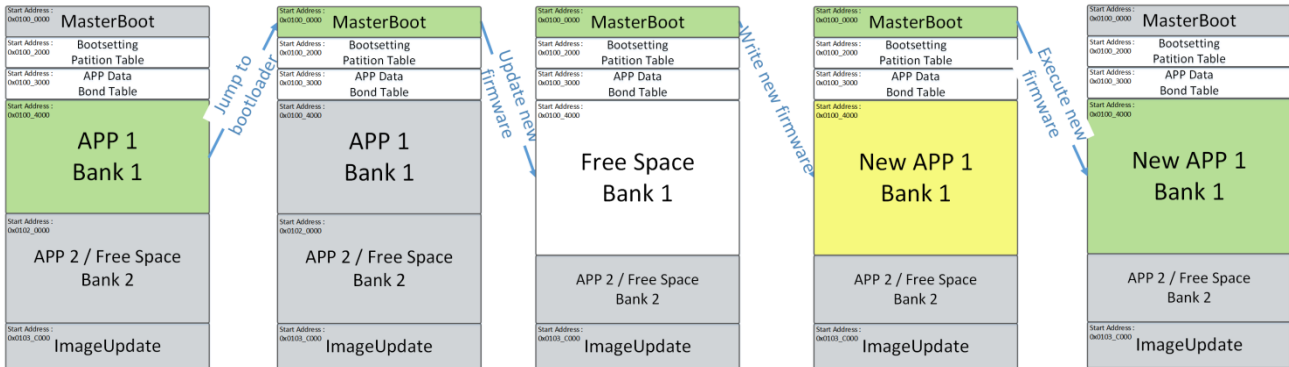
4.1 Serial port update process

The configuration (*set force_update=True*) in *UartFirmwareUpdate.bat*, sets the MasterBootForceUpdate variable in the bootsetting data, resets the software, and enables the MasterBoot program.

Set the MasterBoot Force Update variable and activate the serial port update process.

The MasterBoot receives new firmware through serial port, erases the original firmware in the bank 1 area, writes in the new firmware, and afterwards activates them, and finally jumps to new firmware for execution.

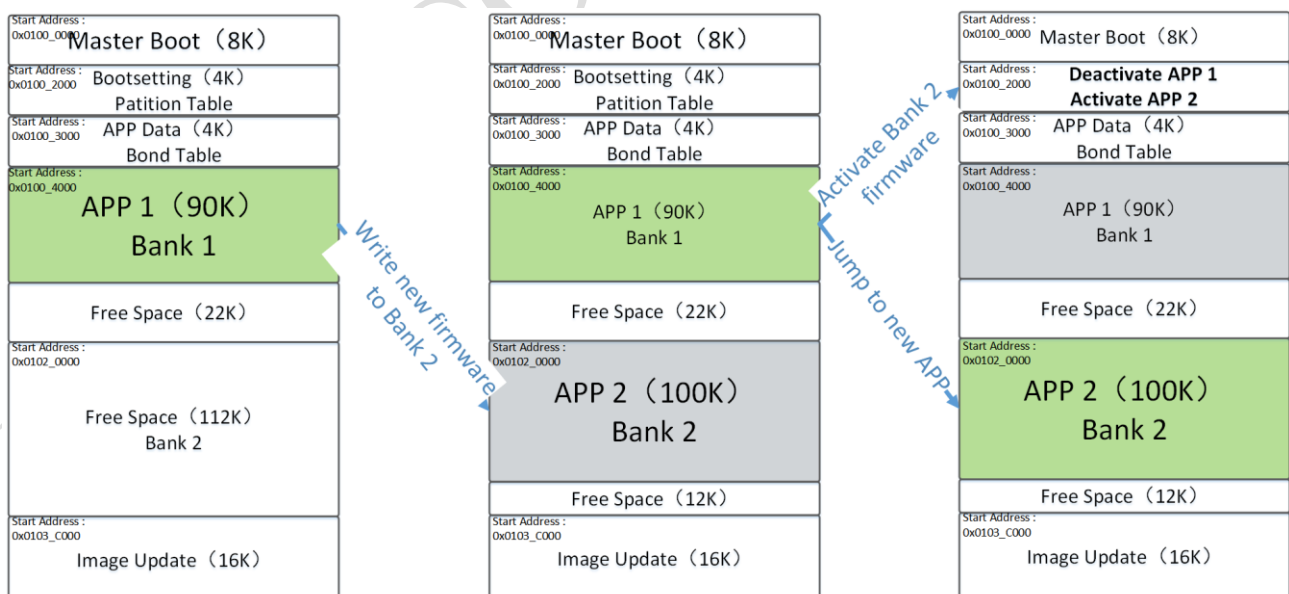
4.2 Update process of Bluetooth dual bank

The “dual bank” update is implemented by updating APP1 with APP2, or vice versa. It features faster update speed and higher stability. However, it also faces the disadvantage that the user program can only use half of the FLASH area. An additional bin file of bank2 needs to be generated when we make the update package.

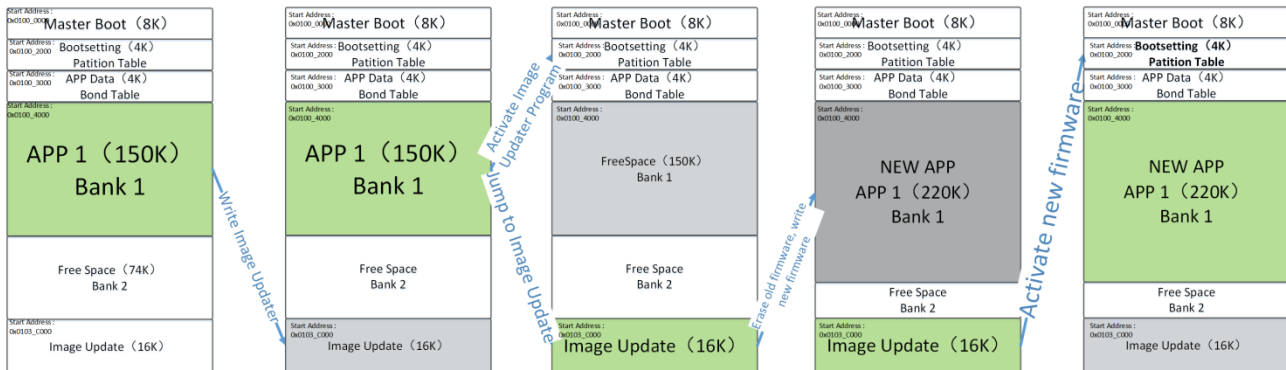
4.3 Update process of Bluetooth single bank

“single bank” update is implemented by updating APP1 program with ImageUpdate program. It has the advantage that the user program can use all FLASH regions, but it also faces the disadvantage of slow update speed, because Bluetooth will disconnection then re-connect causing possible unstable connection and there is no backup when the update fails.

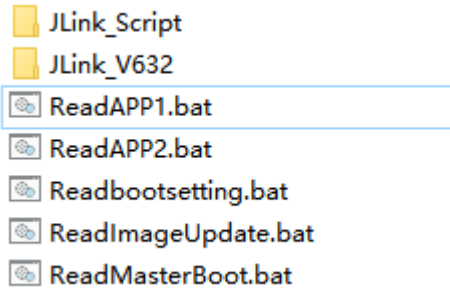
Enter N32WB03x_SDK\utilities\dfu\JLink\directory

JLink_V632 folder contains a JLINK tool manufactured by SEGGER. Users need to install a JLINK driver before use.

JLink_Script folder contains a JLink script file. Users can read the data in the chip's Flash by double-clicking the file *Read XX.bat*.
